MISCELLANEOUS PAPER GL-90-12

CONDITION SURVEY AND PAVER IMPLEMENTATION, EDWARDS AIR FORCE BASE (SOUTH BASE), CALIFORNIA

Ross A. Bentsen

August 1990

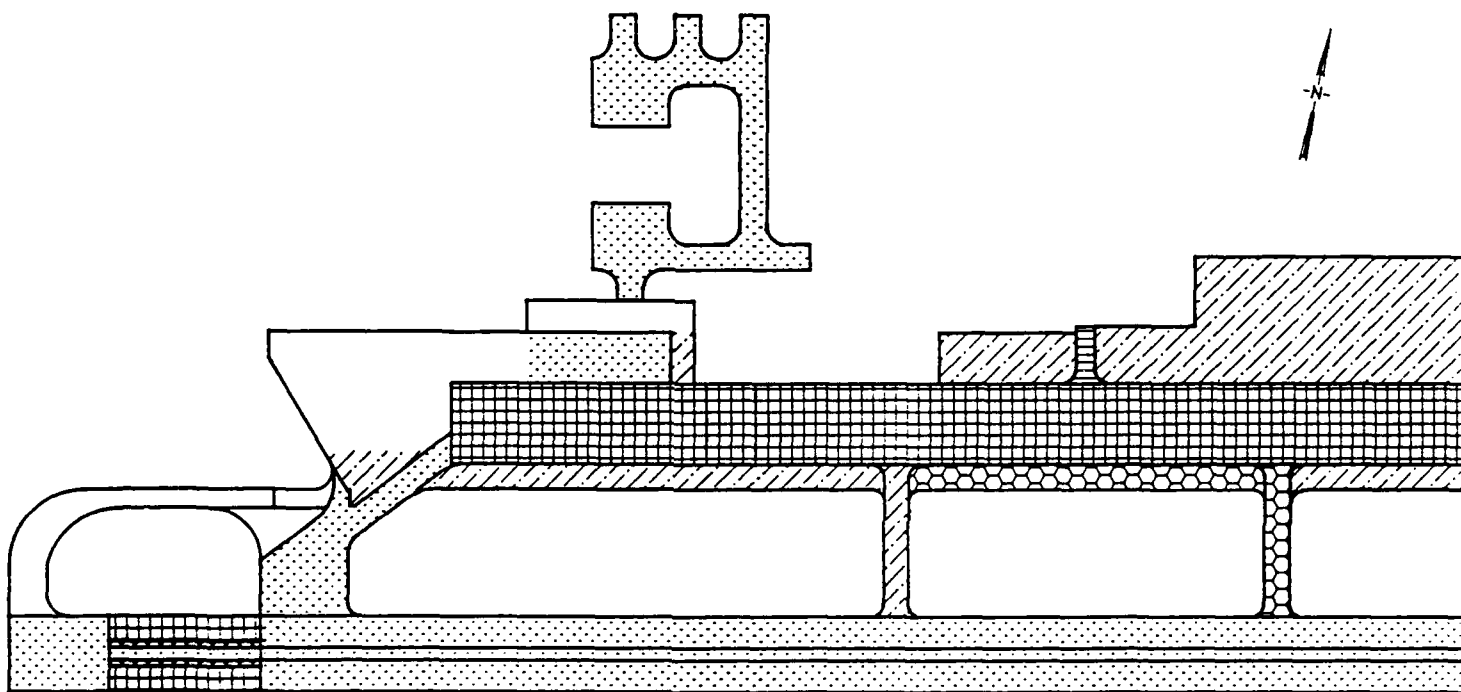
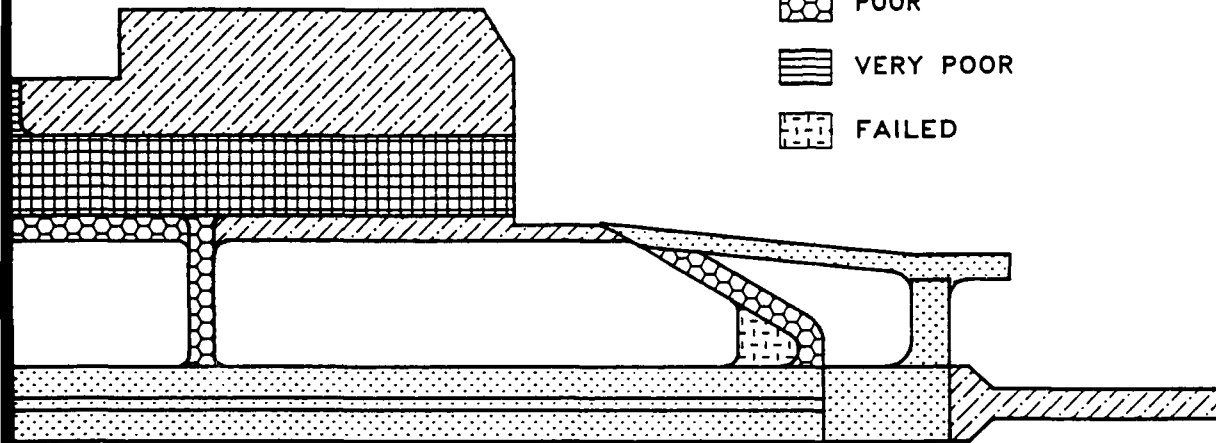
Figure 17. Pavement condition ratings of South B

13. The majority of the pavement features at South Base are rated from fair to very good condition with some features rated from poor to excellent. Figure 17 illustrates the condition ratings of the features at South Base. Features T1C, T2C, and T3C were not due to the construction of an ordinance road down the taxiway length. Section 2 of feature A3B is inside the B-2 test facility and was not surveyed due to its proximity to the security fence. Photos 1 through 14 show various distresses that were observed on the airfield pavements.

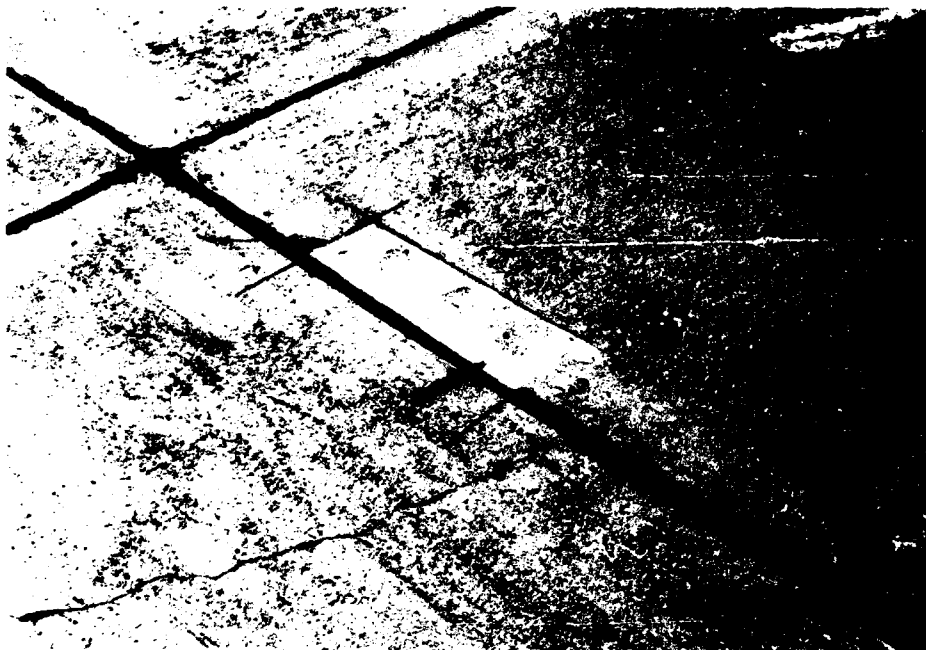
Photo 13. Typical low-severity patch, main apron (A2B)

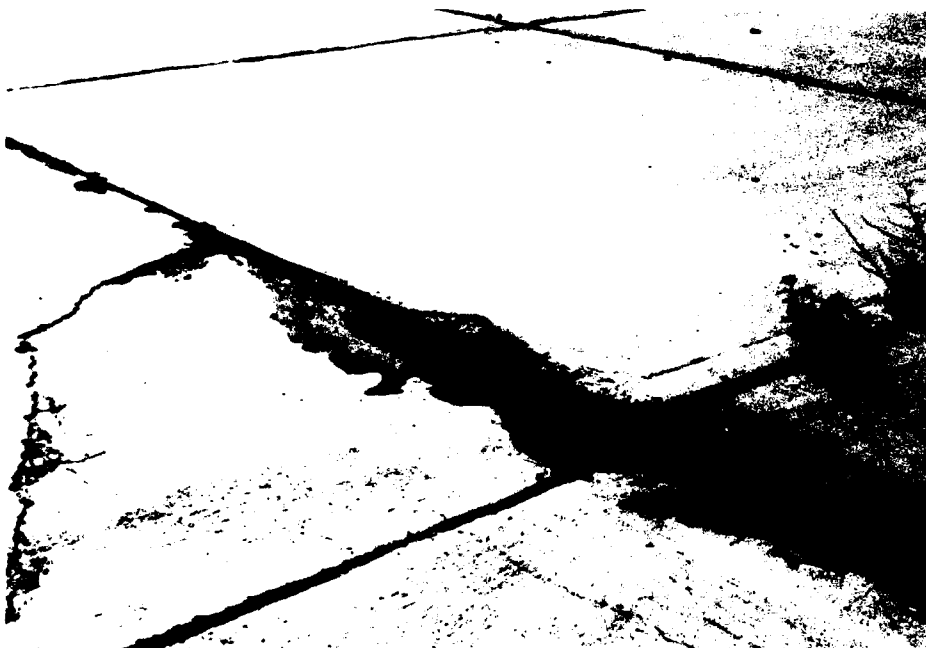
Photo 14. High-severity corner break with settlement, main apron (A2B)
